Exhibit G

SUBJECT: Air leaking into the Ice Room from a gap between the wall and the ice room floor. (Direct Contact Ice Makers only)

SERVICE BULLETIN		
Product:	Refrigerators	
Bulletin Date:	08/18/2014	
Bulletin Number	ASC20140818002	
Models:	RF23HCEDBBC/AA RF28HFEDTBC/AA RF28HFEDTSR/AA RF28HFEDTWW/AA RF28HFPDBSR/AA RF30HBEDBSR/AA RF30HDEDTSR/AA RF31FMEDBBC/AA RF31FMEDBSR/AA RF31FMEDBWW/AA RF31FMESBSR/AA RF323TEDBBC/AA RF323TEDBSR/AA RF323TEDBWW/AA RF32FMQDBSR/AA RF32FMQDBXW/AA RF34H9950S4/AA	RF34H9960S4/AA RF23HCEDBSR/AA RF23HCEDBWW/AA RF24FSEDBSR/AA RF263BEAEBC/AA RF263BEAESP/AA RF263BEAESR/AA RF263BEAEWW/AA RF263TEAEBC/AA RF263TEAESP/AA RF263TEAESR/AA RF263TEAEWW/AA RF28HDEDBSR/AA RF28HDEDTSR/AA RF28HFEDBBC/AA RF28HFEDBSR/AA RF28HFEDBWW/AA

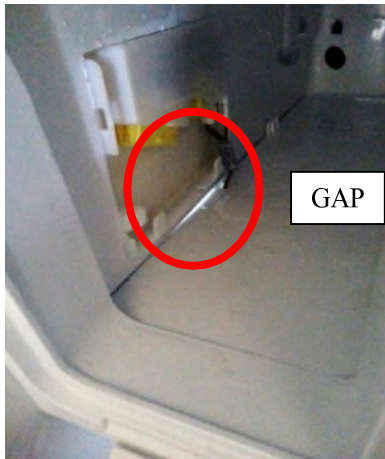
Symptom: Frozen water on ice room floor, ice on bottom of ice maker, water dripping into the fresh food section.

Factory Solution: All new production units now undergo an improved inspection to identify and correct the gap. The new process has been in effect since March 2014.

Field Repair: Apply a bead of RTV Epoxy to the gap to improve the seal between the ice room and the wall.

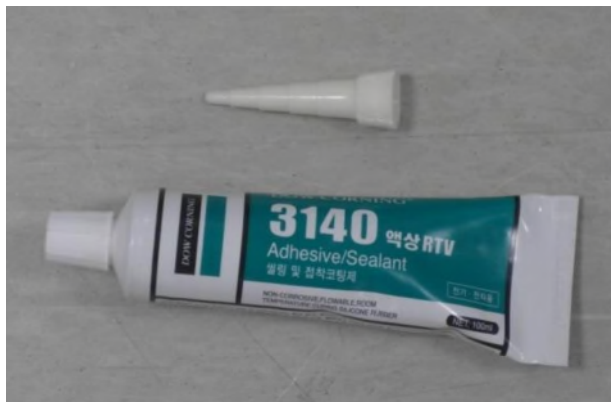
Part number: DA81-05595A A/S Epoxy

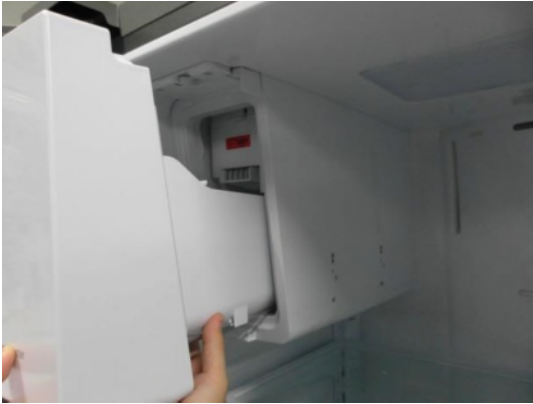
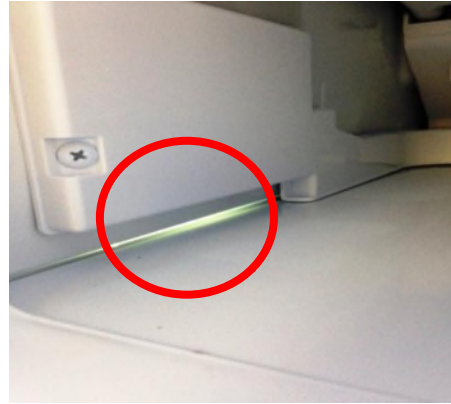
1. Remove the ice bucket and check for a gap. Look for light along the edge.

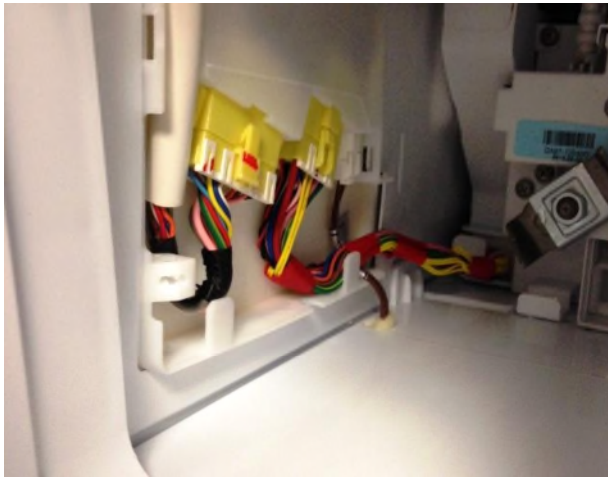
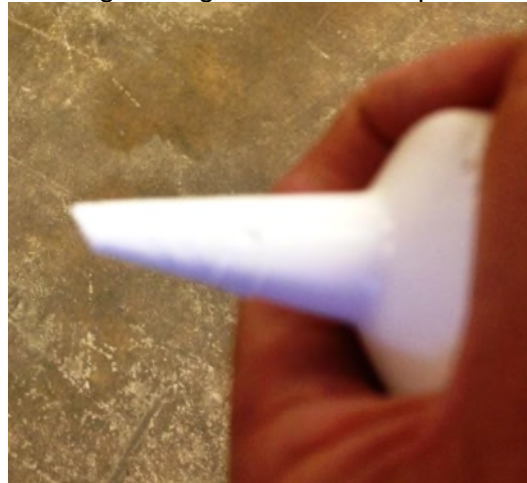
2. If a gap exists, remove the wiring cover.
3. Cut the end of the RTV Epoxy application cap at a 45 degree angle close to the tip.

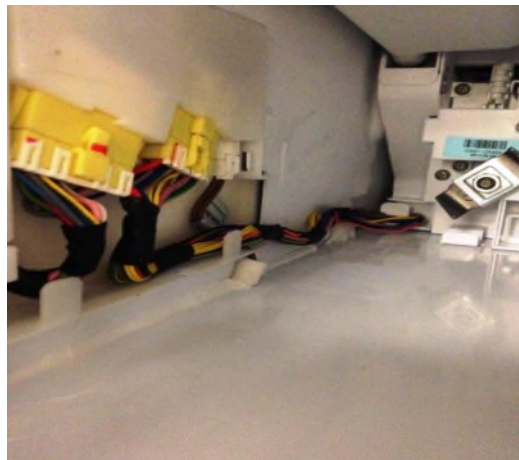
4. Make sure the ice room floor is completely dry.
5. Apply a thin bead of RTV from the back to the front to fill the gap.
6. Verify that the light no longer shines through.
7. Reinstall the wiring cover and the ice bucket.
